Impact Sound Testing of Floor Covering on a Heavyweight Standard Floor

Report INR171/R1
June 2011

Gerflor Australasia Pty Ltd
17 Cato Street
Hawthorn East
VIC 3123

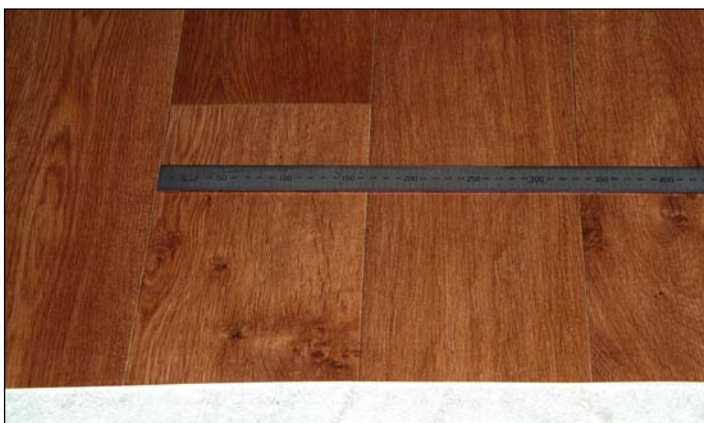
Test 'a'

Trade Name: Texline HQR
Description: Sheet vinyl with textile backing, supplied in the form of a single roll, 4 m wide
Thickness: 3.1 mm (0.35 mm wear layer)
Mass per unit area: 2370 g/m²

Floor Materials Tested: “Gerflor Texline HQR”

Type of Material: Sheet vinyl (woodgrain appearance) with textile backing
 Form: Continuous roll, 4 m wide
 Thickness: 3.1 mm (0.35 mm wear layer)
 Mass per unit area: 2370 g/m²
 Underlying floor: Reinforced concrete slab, 3.68 m (l) x 3.22 m (w) x 150 mm (thick)

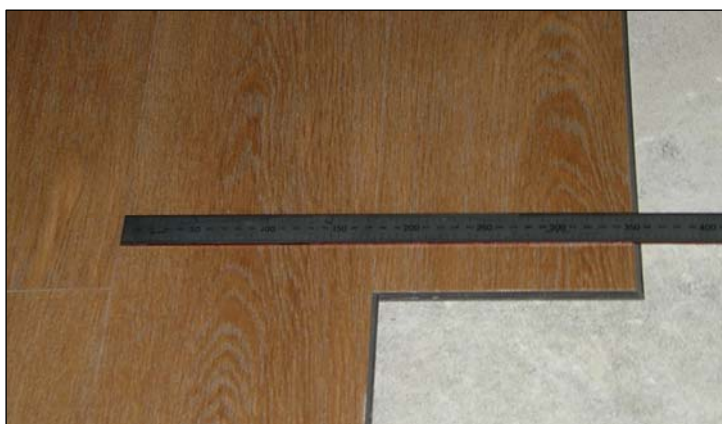
Test 'b'

Trade Name: Creation Clic
Description: Vinyl planks, 17.6 x 100 cm, interlocking by means of mating edge profiles
Thickness: 6 mm (0.7 mm wear layer)
Mass per unit area: 9895 g/m²

Floor Materials Tested: “Gerflor Creation Clic”

Type of Material: Vinyl (woodgrain appearance)
 Form: Interlocking Planks, 17.6 cm x 100 cm
 Thickness: 6 mm (0.7 mm wear layer)
 Mass per unit area: 9895 g/m²
 Underlying floor: Reinforced concrete slab, 3.68 m (l) x 3.22 m (w) x 150 mm (thick)

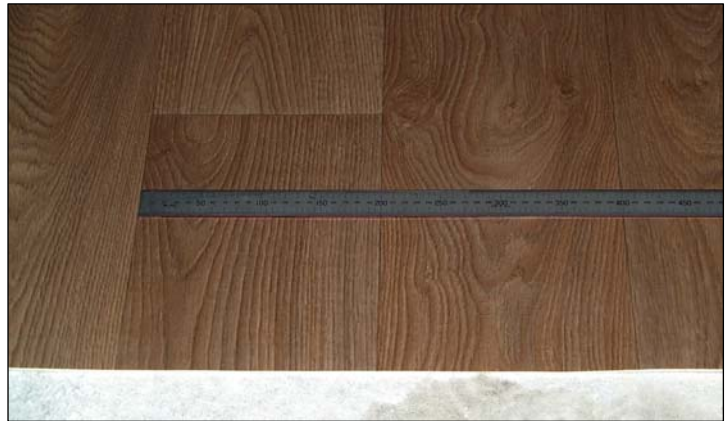
Test 'c'

Trade Name: Texline Comfort
Description: PVC Surface with polyester textile backing, supplied in the form of a single roll, 4 m wide
Thickness: 4.2 mm (0.3 mm wear layer)
Mass per unit area: 2440 g/m²

Floor Materials Tested: “Gerflor Texline Comfort”

Type of Material: Sheet vinyl (woodgrain appearance) with polyester textile backing
 Form: Continuous roll, 4 m wide
 Thickness: 4.2 mm (0.3 mm wear layer)
 Mass per unit area: 2440 g/m²
 Underlying floor: Reinforced concrete slab, 3.68 m (l) x 3.22 m (w) x 150 mm (thick)
